Manhole Inspection Summary

Manhole # S31SS_020MH

Insp Date: **5/9/07 11:53 AM**

Location Address: **2701 CRESTMONT AVE**

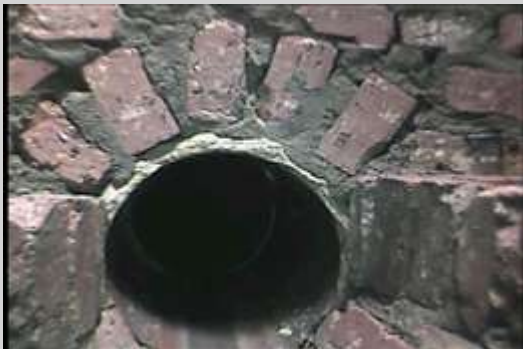
8 in. Circular Gravity Sewer Pipe In @ 3 O'Clock

Pipe Material: **Clay** ☐ Pipe Lined

Invert Depth: **6.28** (ft.) Flow Characteristics: **Slow**

Deposits: ☒ None ☐ Mud ☐ Sludge ☐ Debris ☐ Grease

Infiltration: **None** Pipe Seal Cond: **Unknown**

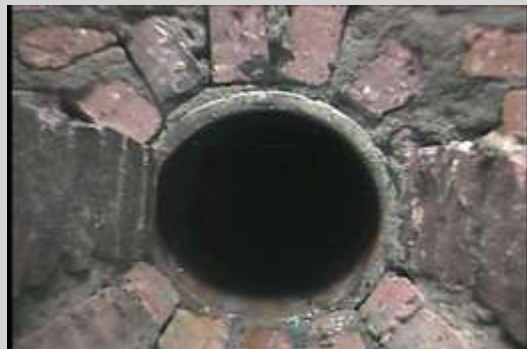
8 in. Circular Gravity Sewer

Pipe Material: **Clay**

Infiltration: **None**
